MEMOIRS OF THE
ARCHAEOLOGICAL SURVEY OF INDIA
NO. 91

ANGKOR VAT

INDIA'S CONTRIBUTION IN CONSERVATION

1986-1993

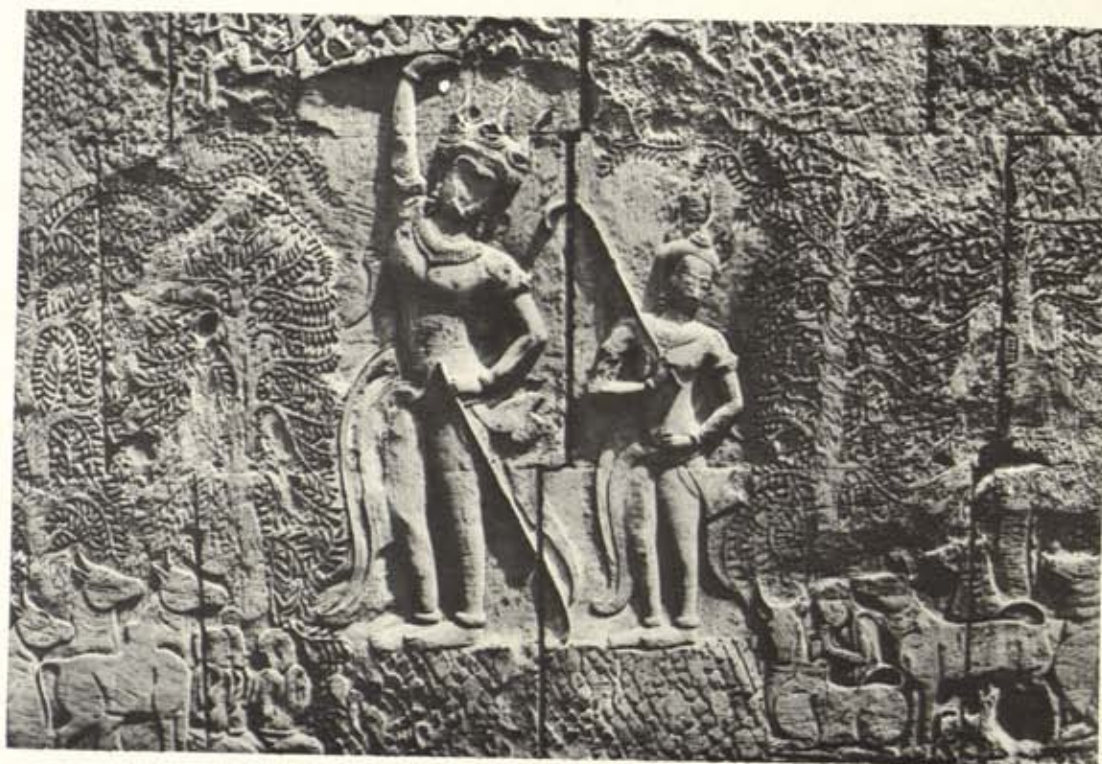
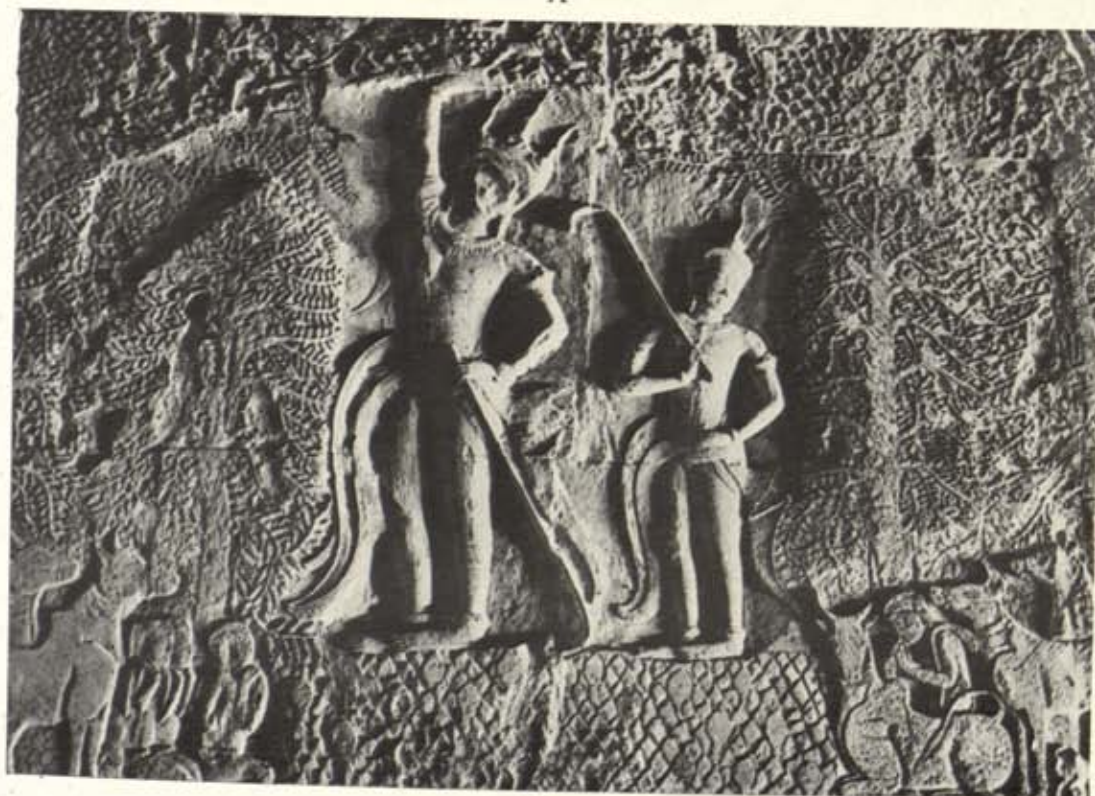
Third Enclosure : south-western corner entrance pavilion, A, before and B, after conservation

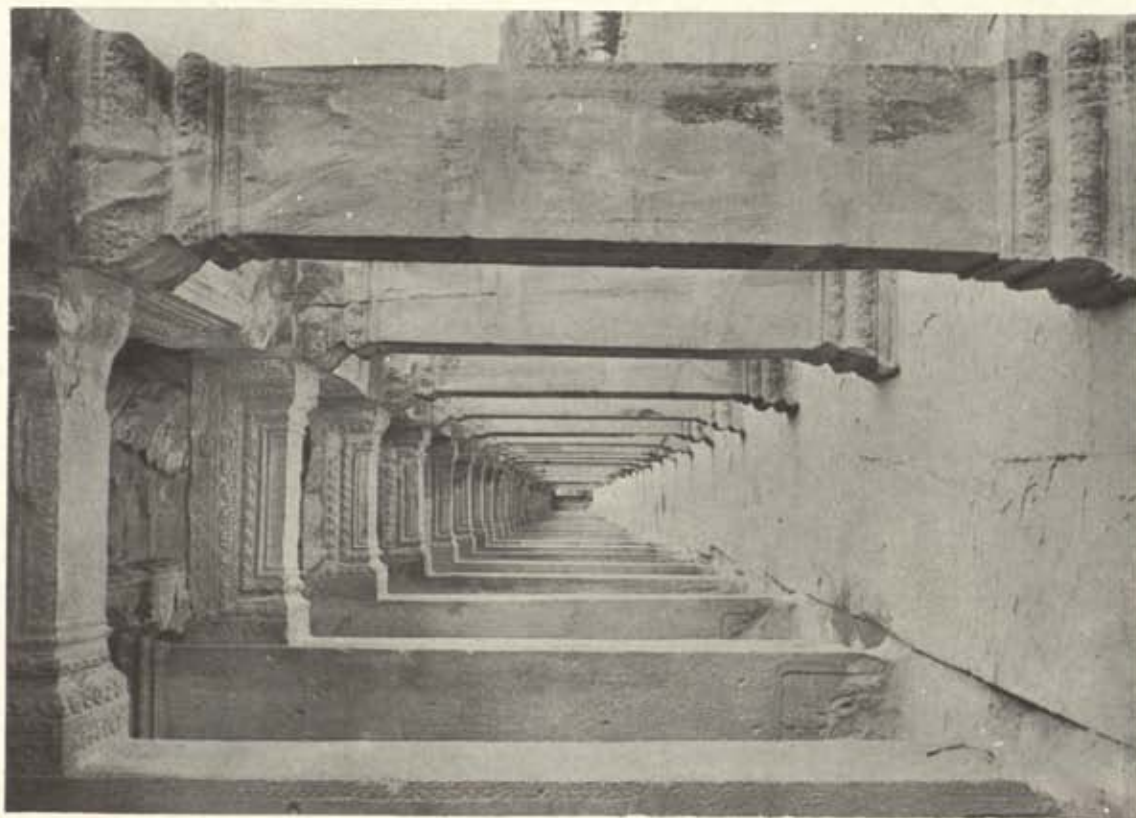
B

Third Enclosure : Western Gallery, A, before and B, after conservation

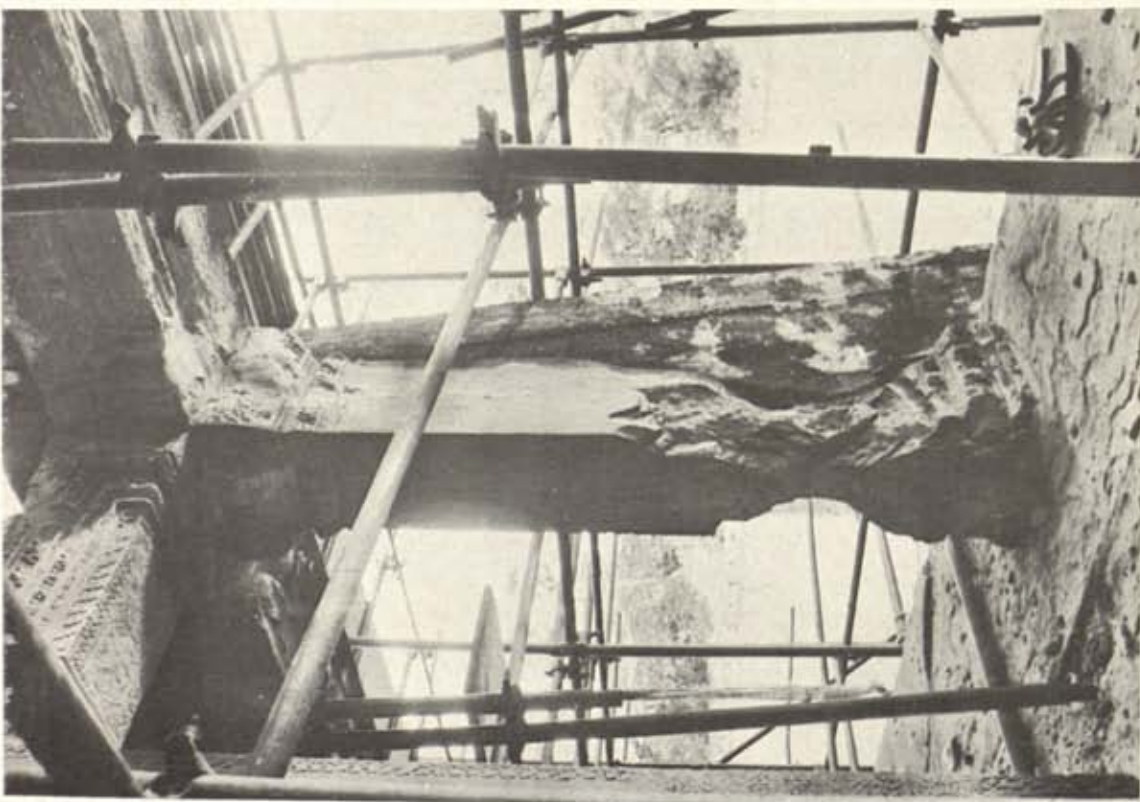
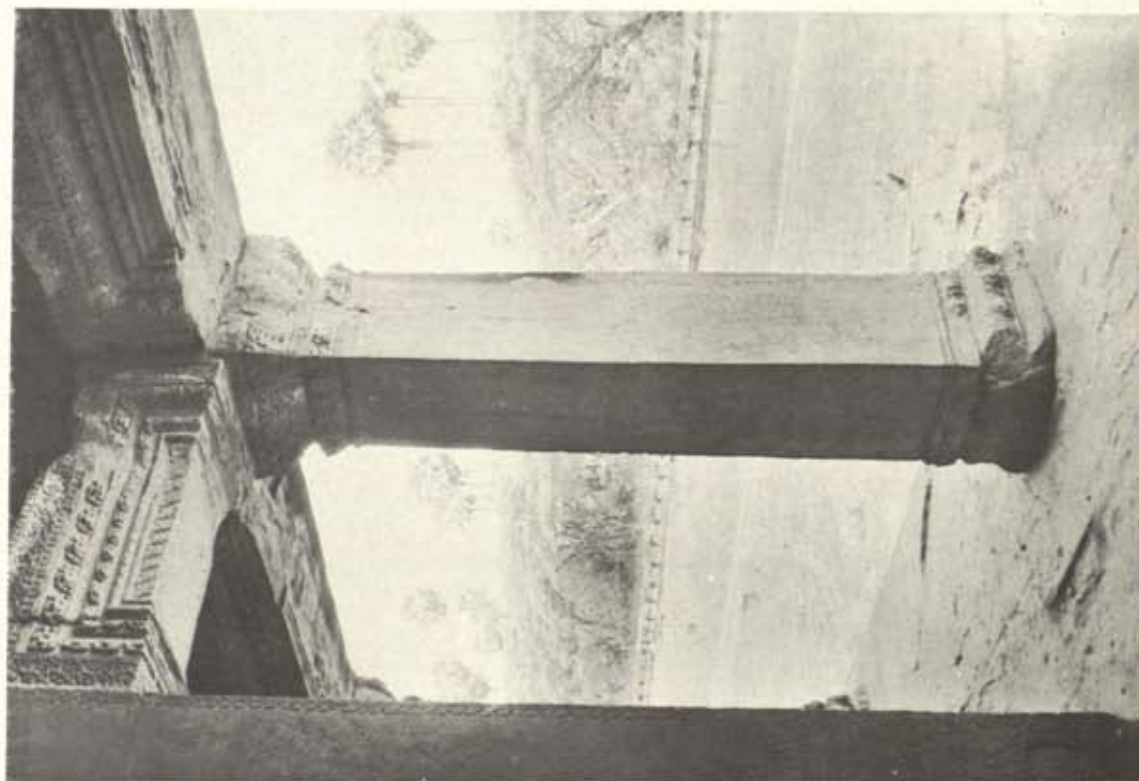
Third Enclosure : Western Gallery. A, before and B, after conservation

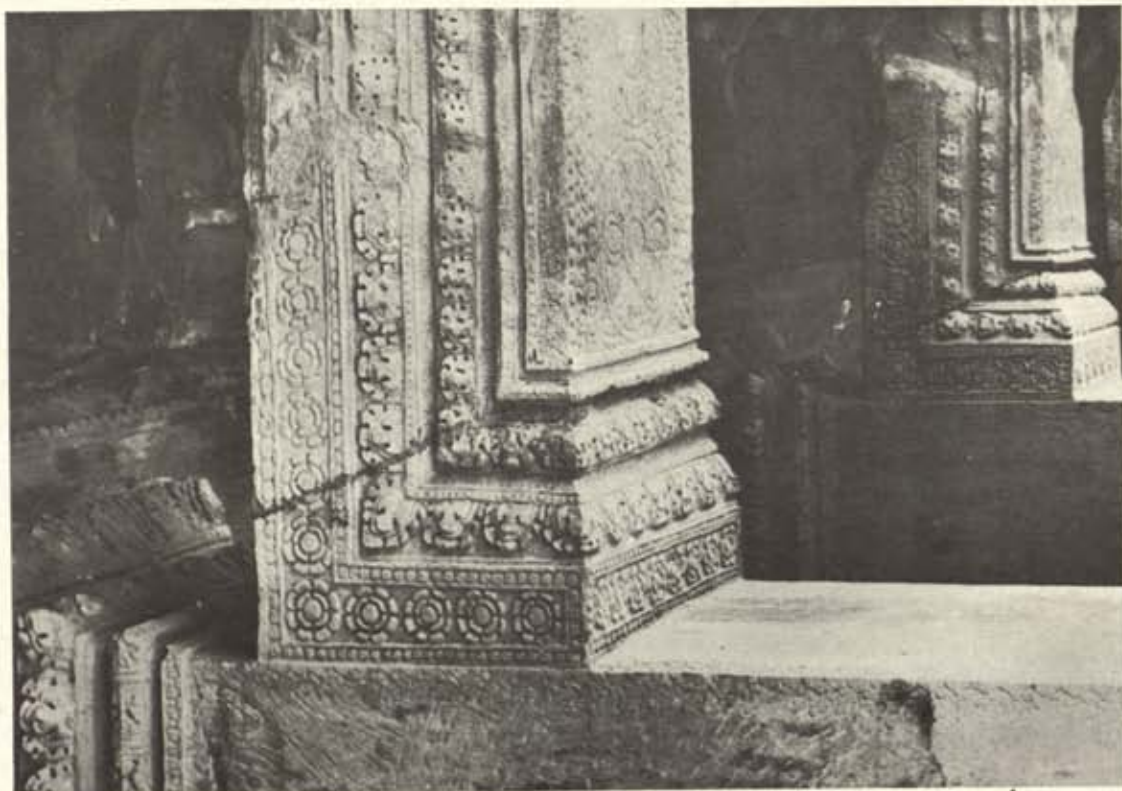
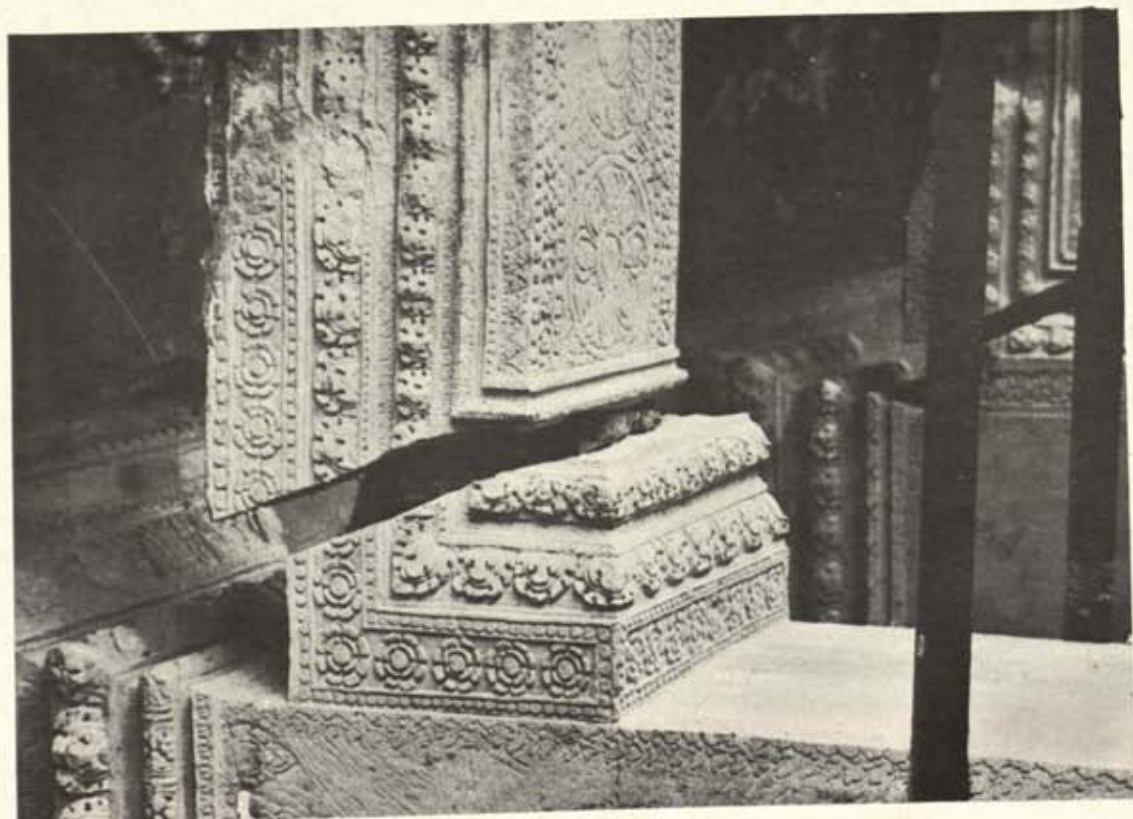
Third Enclosure : Western Gallery, A, before and B, after conservation

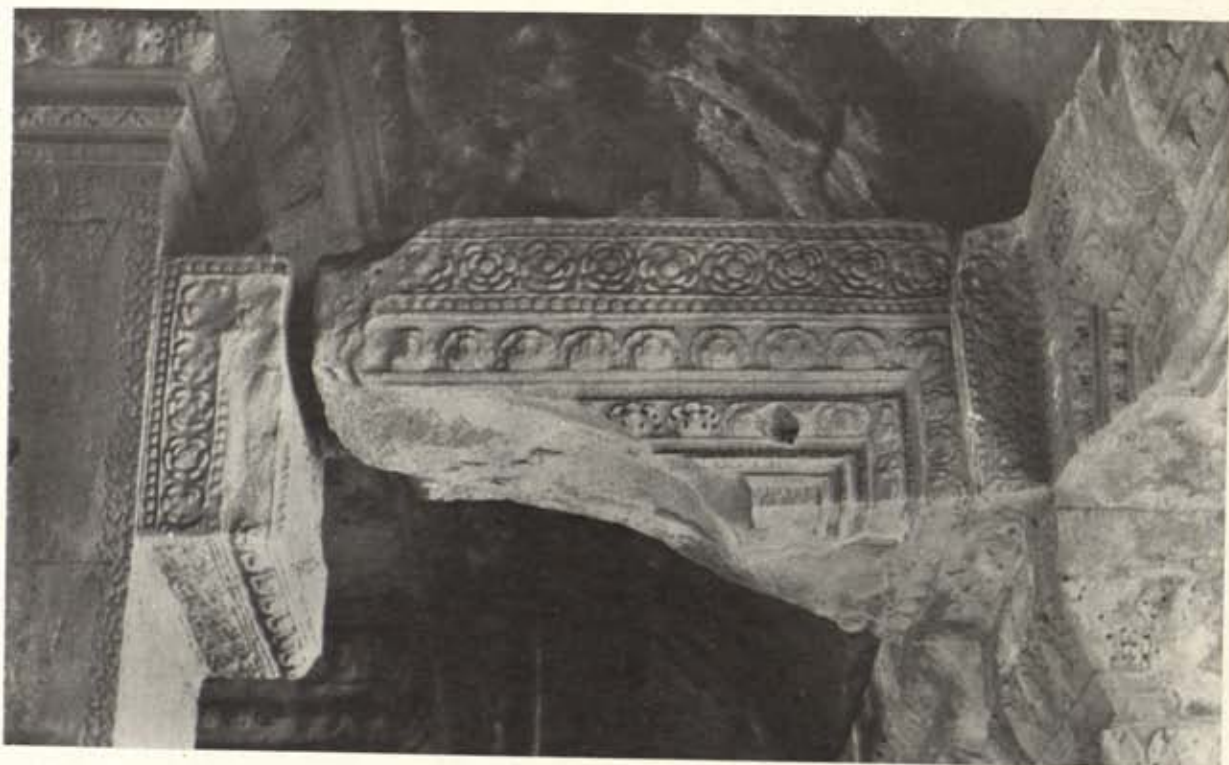
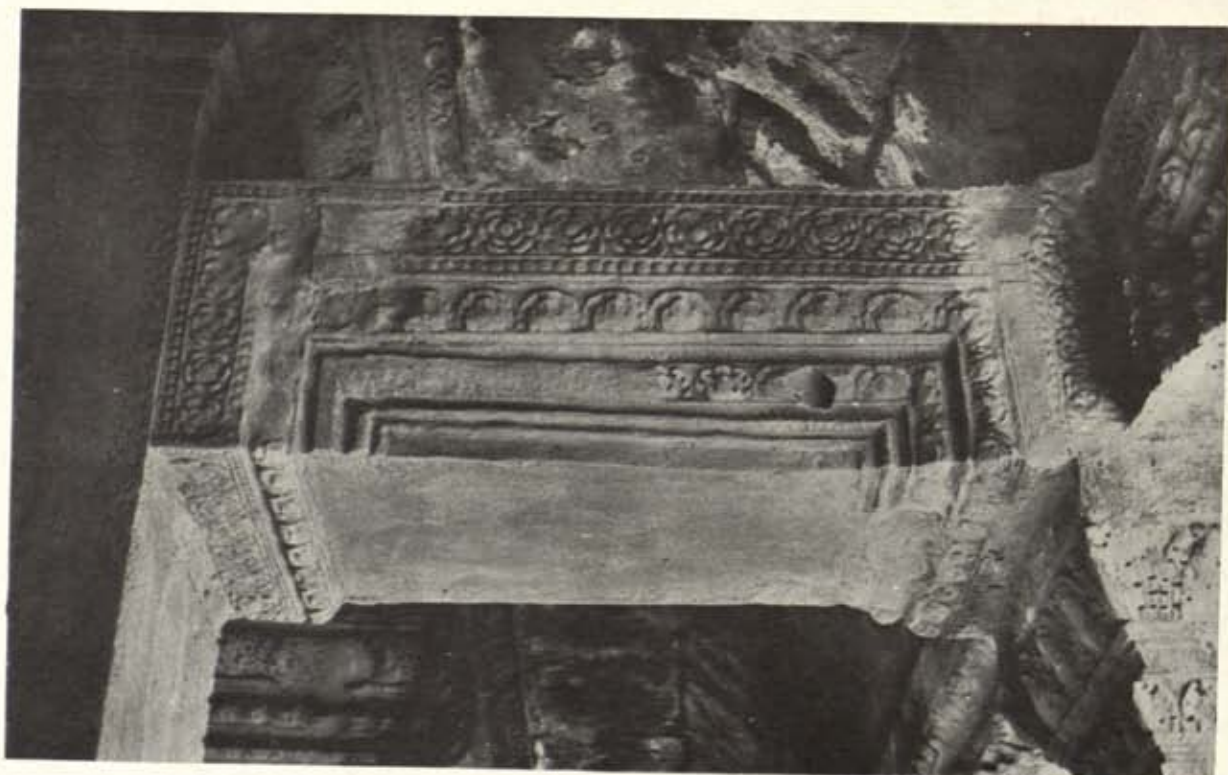
Third Enclosure : Eastern Gallery. A, before and B, after conservation

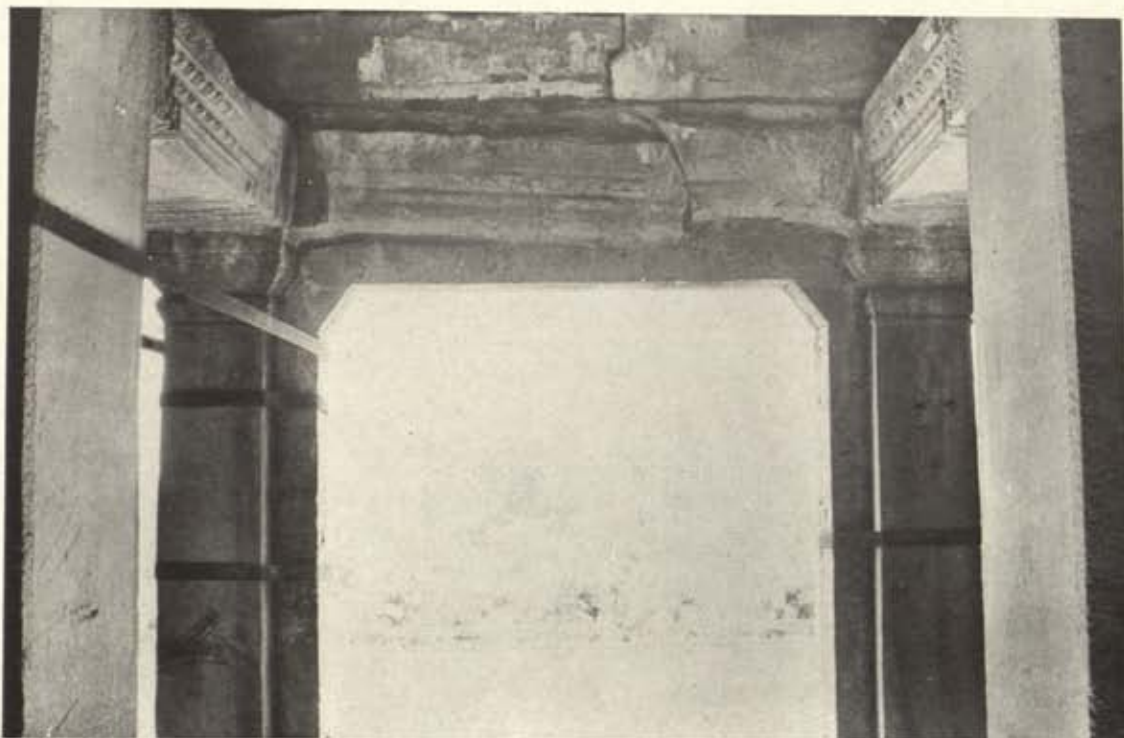
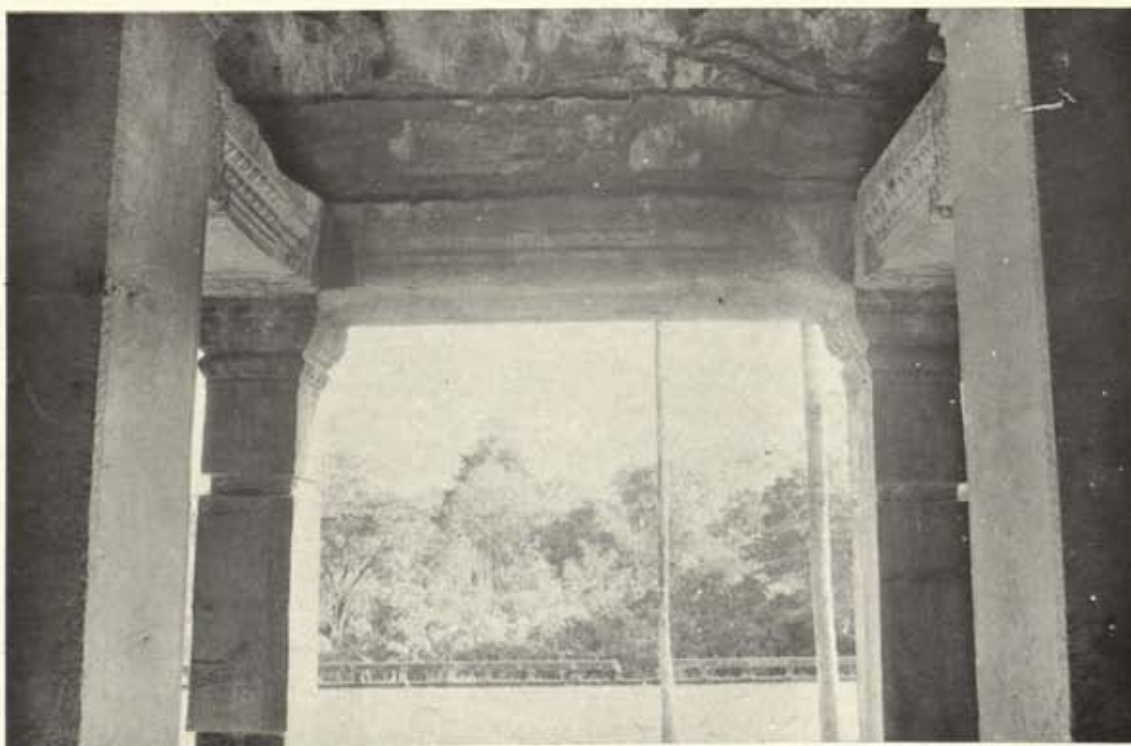
Third Enclosure : Eastern Gallery, A, before and B, after conservation

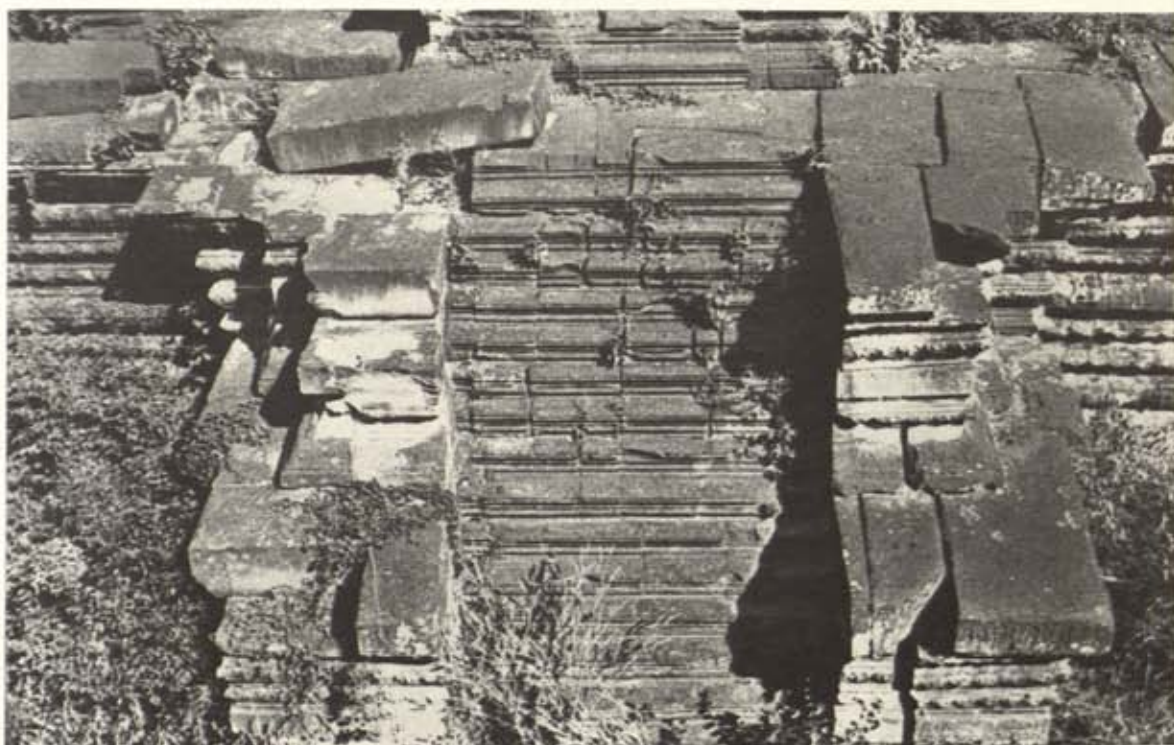
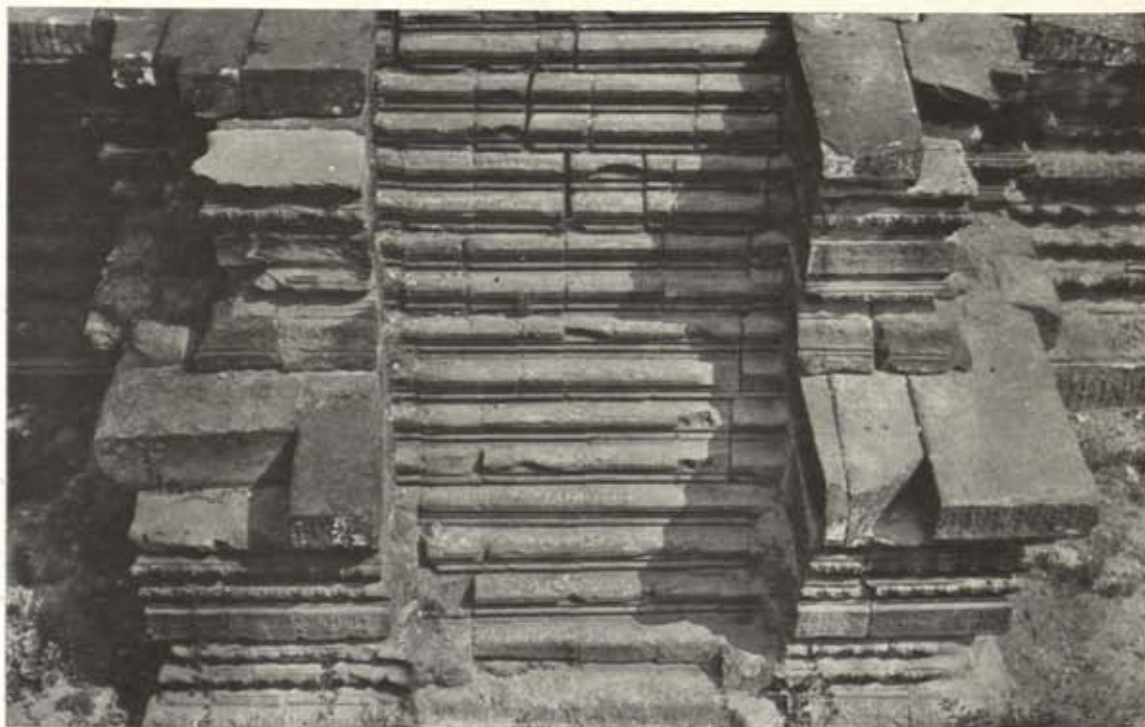
*Southern Library between Second and Third Enclosures : southern stepped entrance,
A, before and B, after conservation*

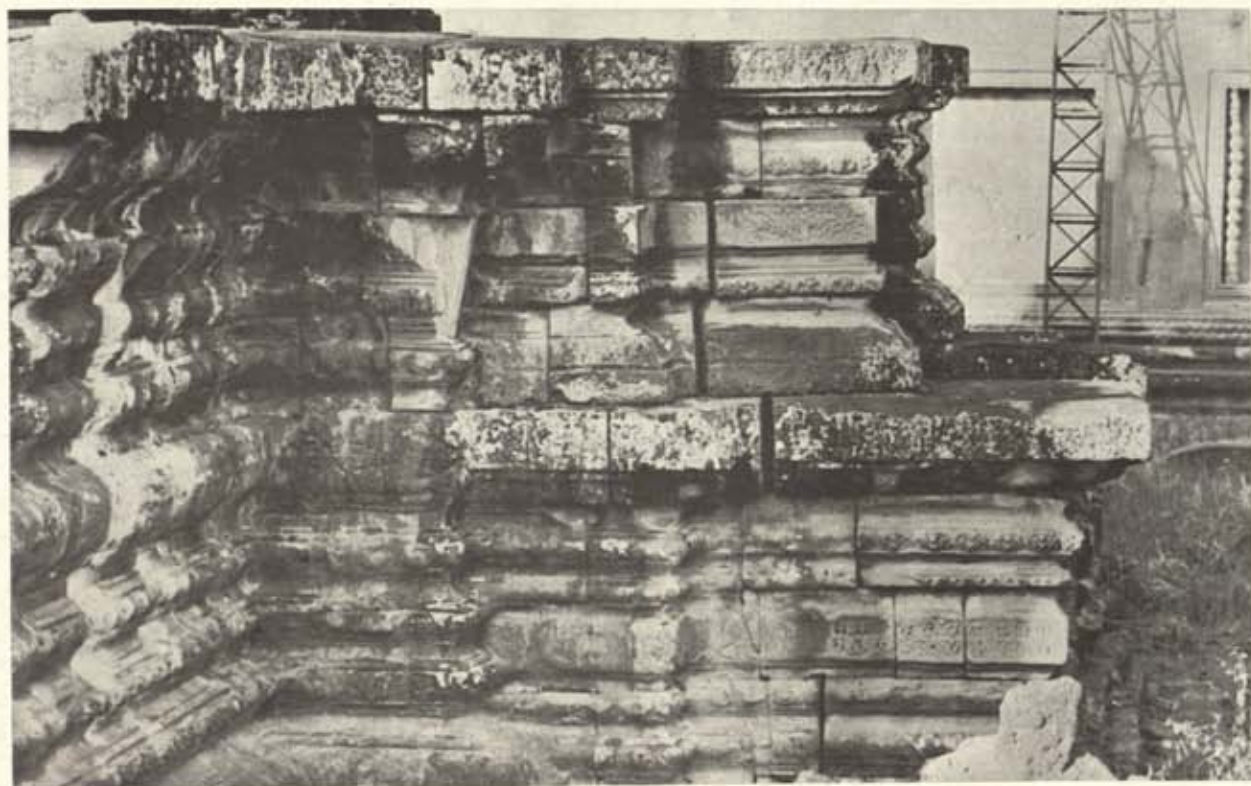
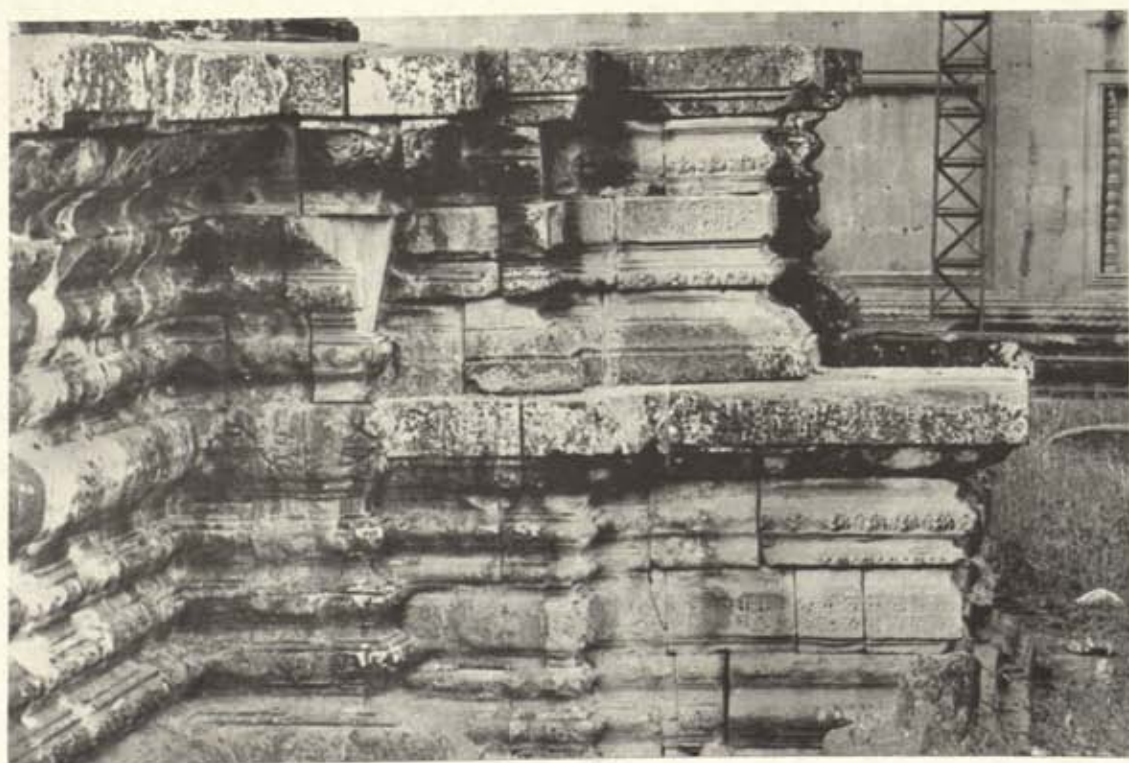
*Southern Library between Second and Third Enclosures : northern stepped entrance,
A, before and B, after conservation*

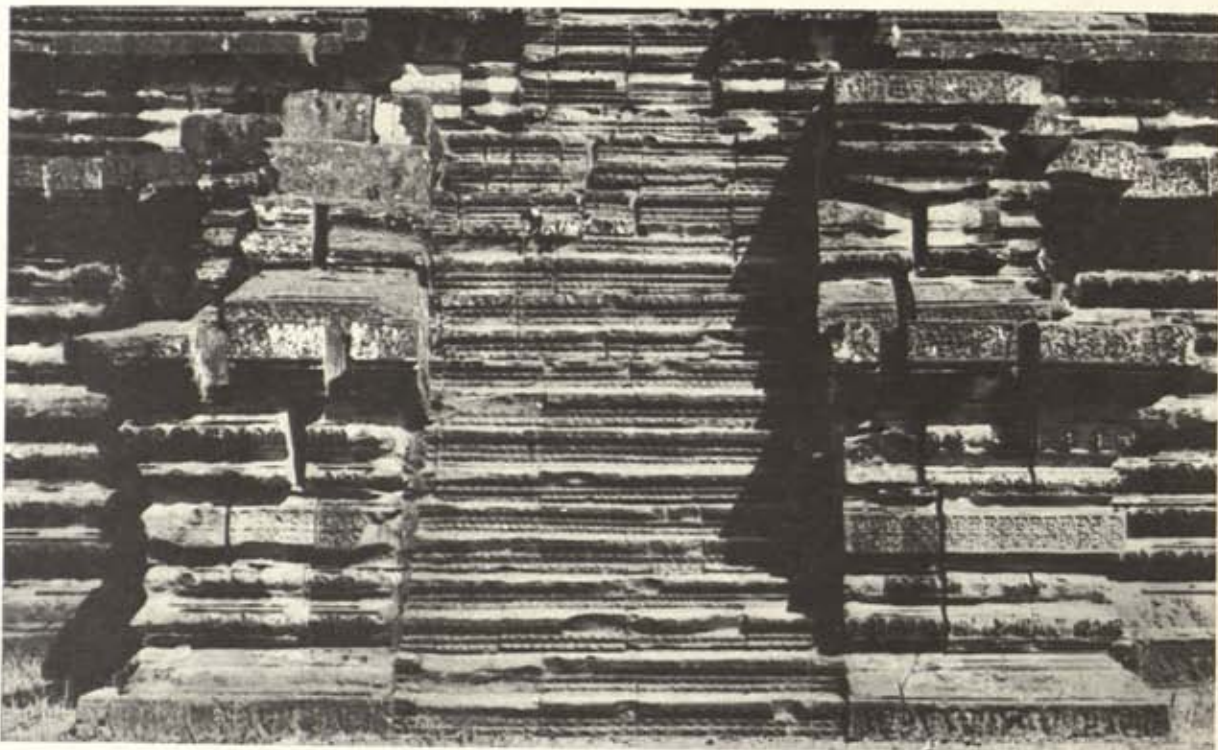
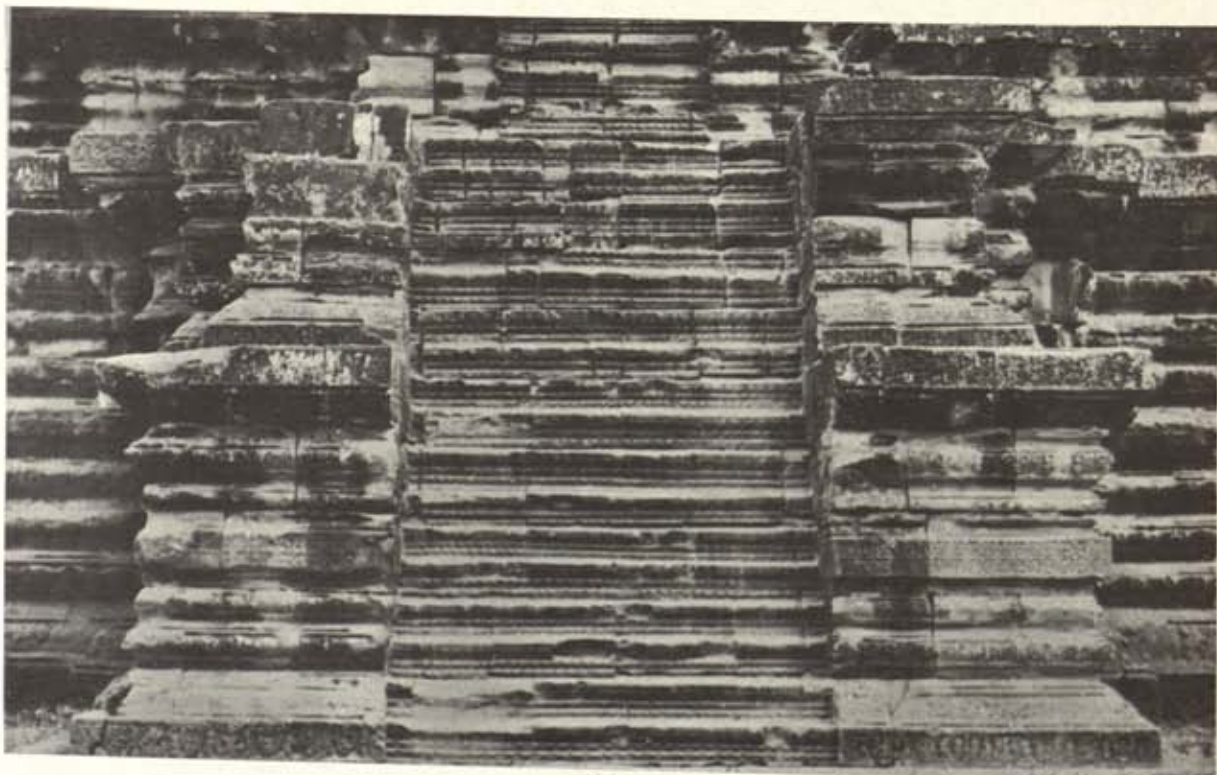
*Northern Library between Second and Third Enclosures : southern stepped entrance,
A, before and B, after conservation*

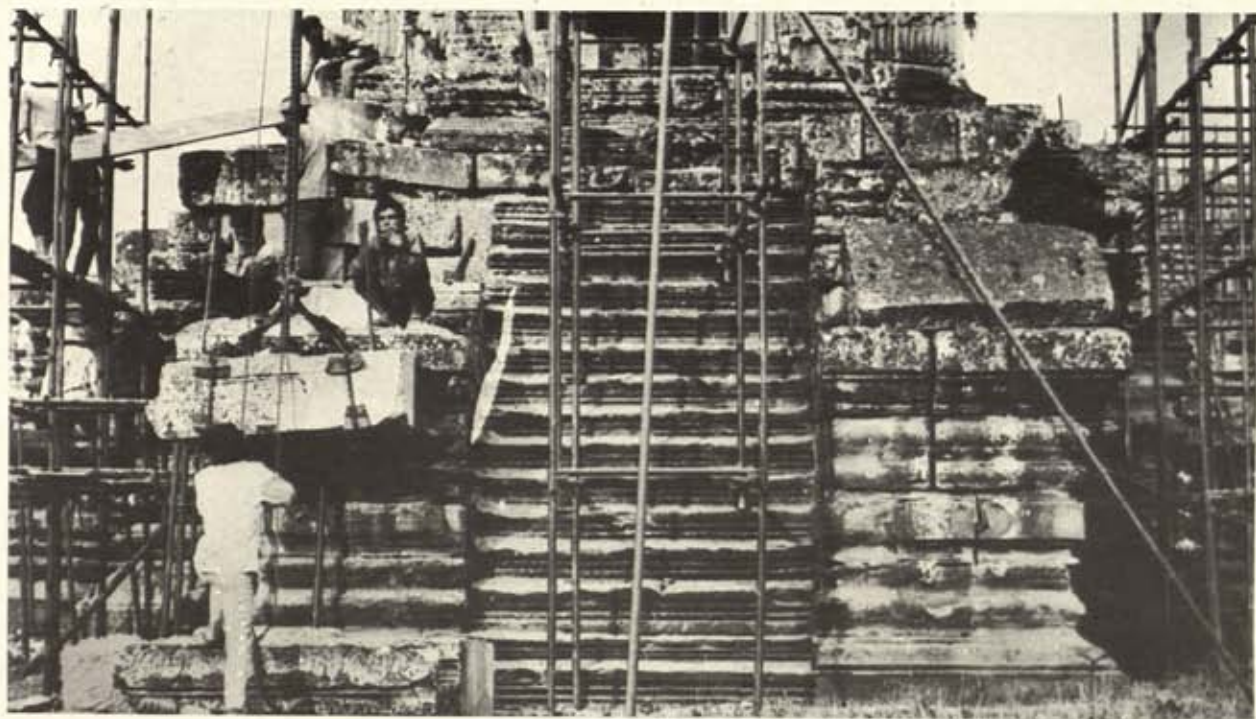
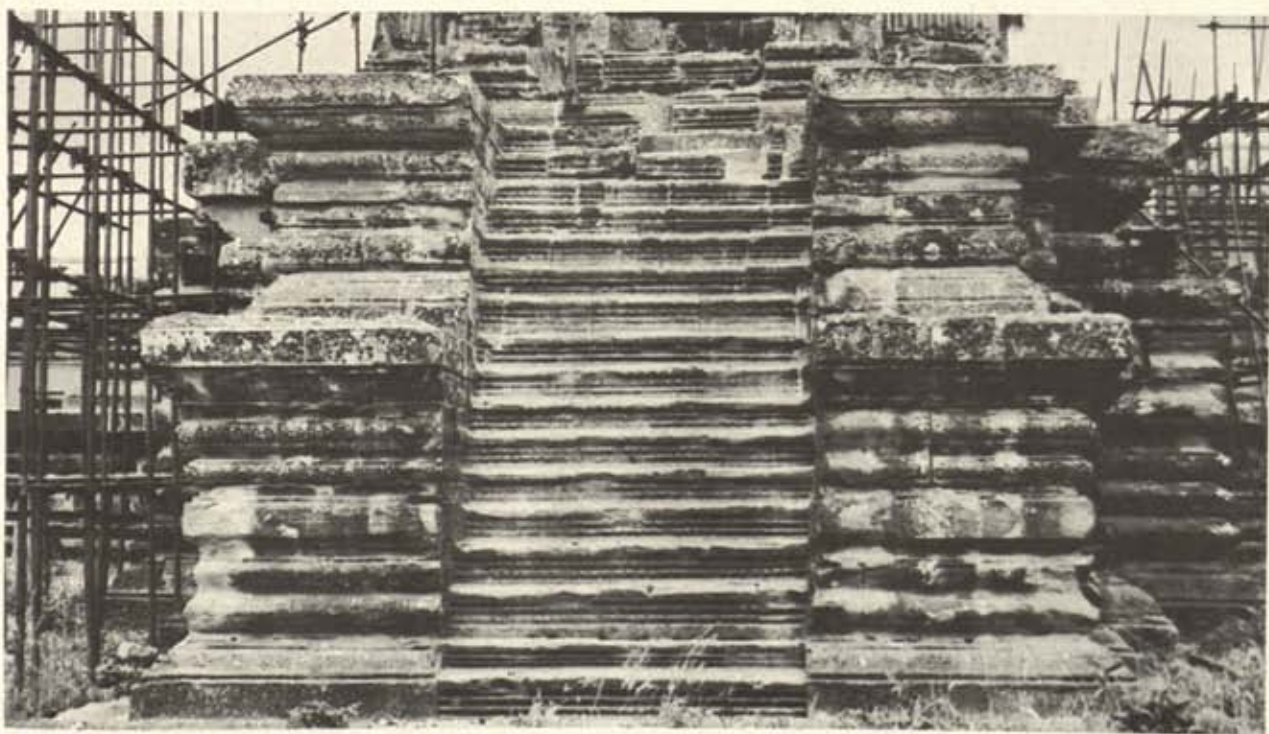
*Northern Library between Second and Third Enclosures : eastern stepped entrance,
A, during and B, after conservation*

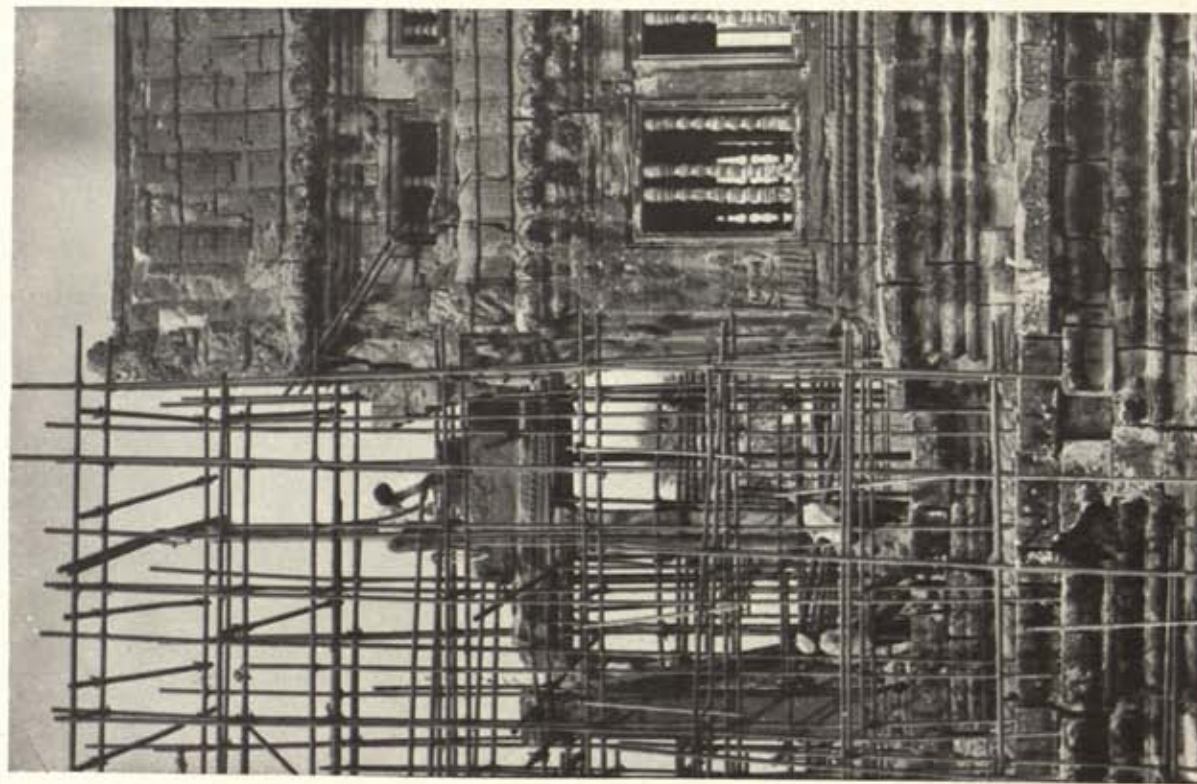
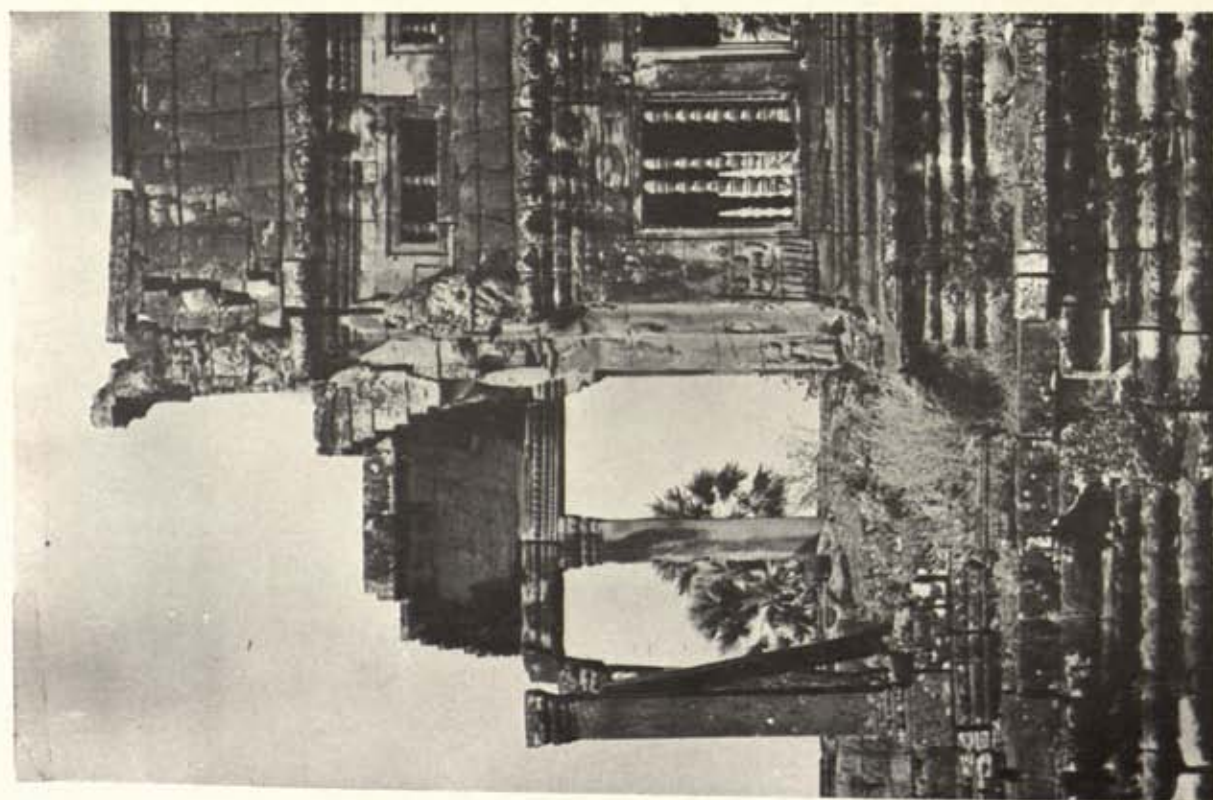
Northern Library between Second and Third Enclosures: westernmost torana, A, before and B, after conservation

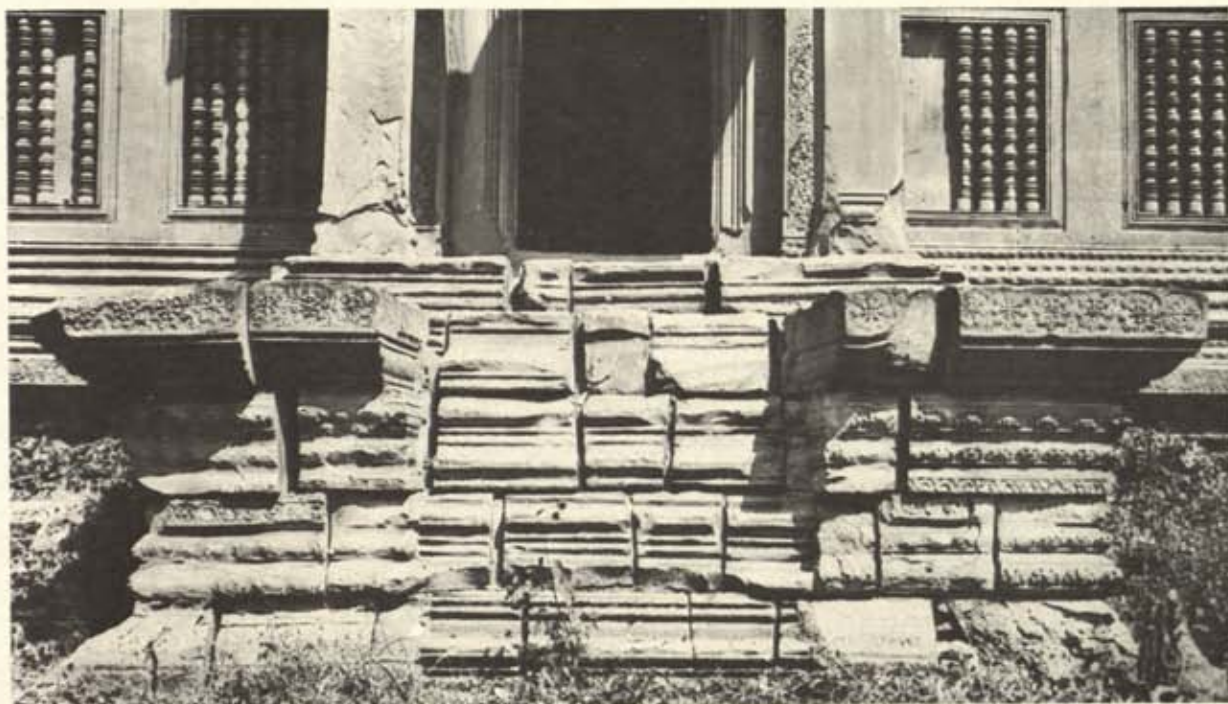
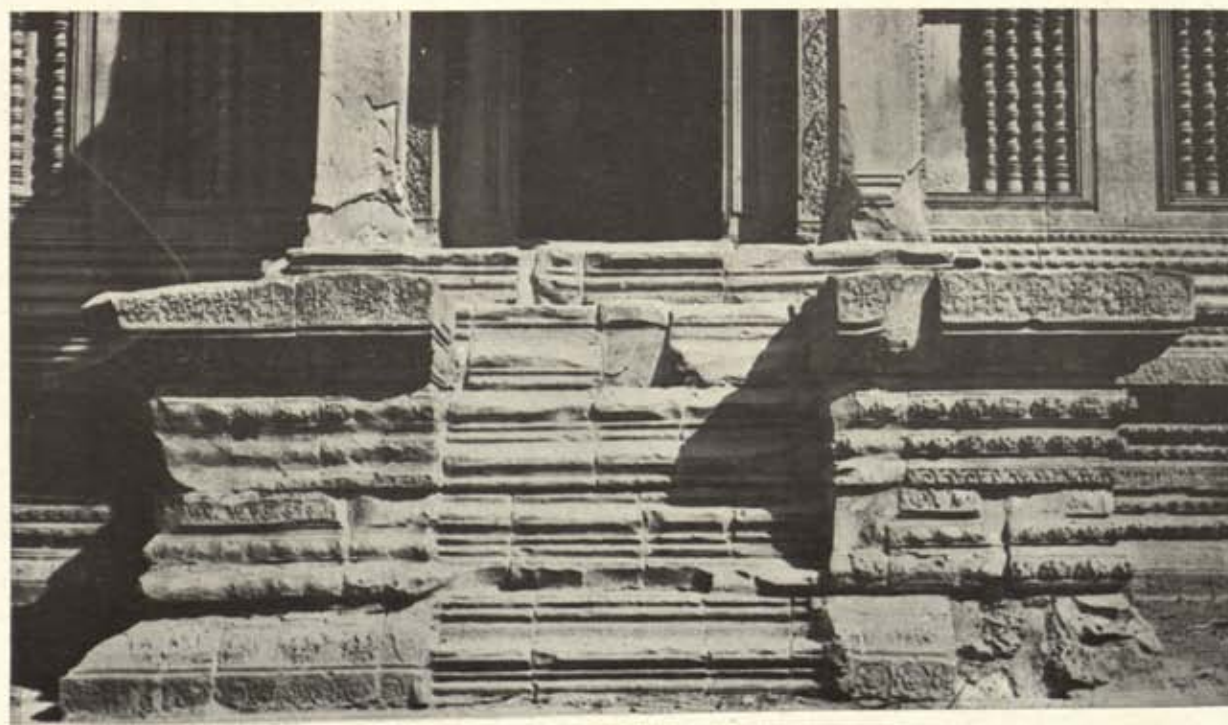
*Antechamber between Second and Third Enclosures: southern stepped entrance,
A, before and B, after conservation*

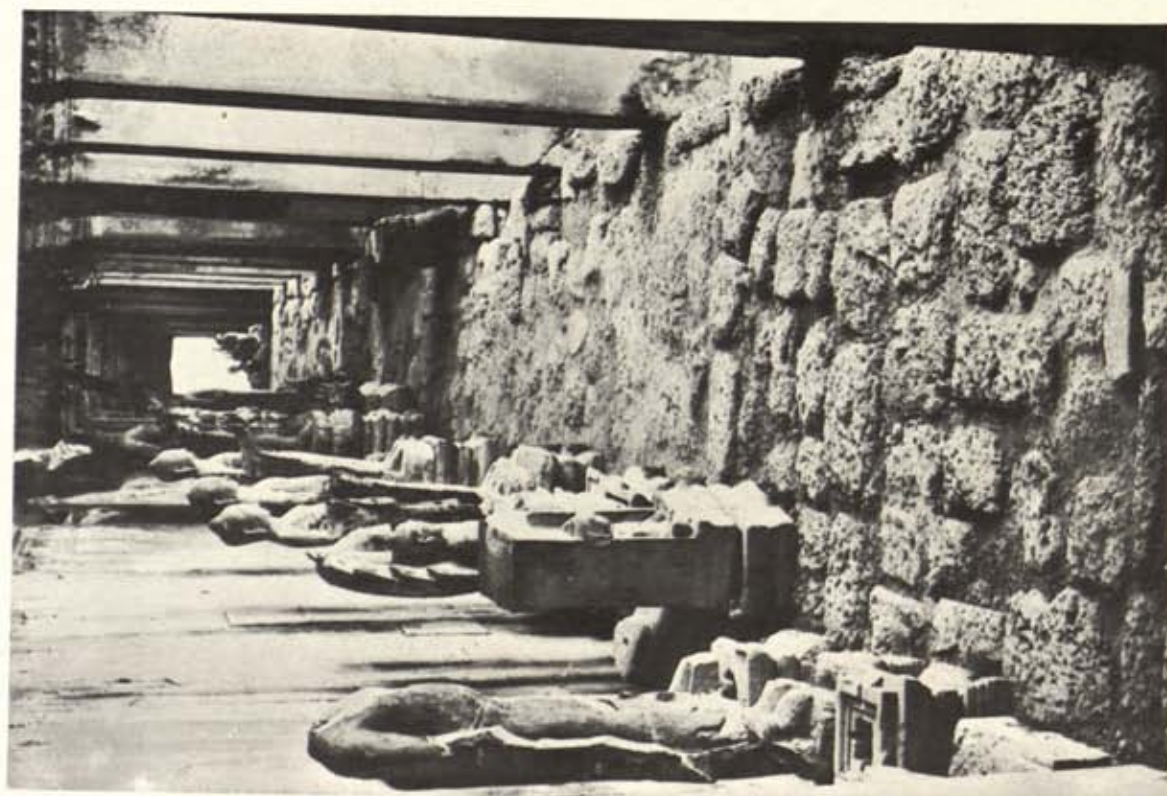
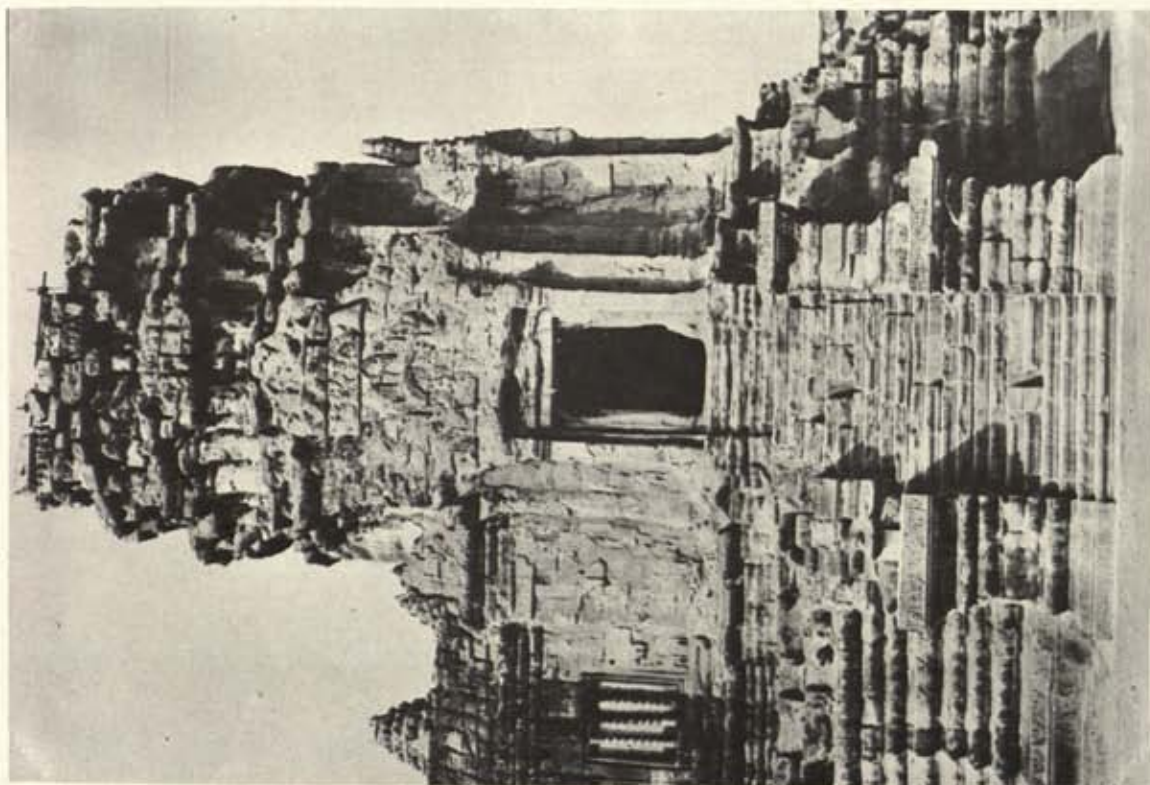
Antechamber between Second and Third Enclosures: Southern Gallery, A, before and B, after conservation
